Subject: Boeing EQA Report on Slats, Passenger Windows, Fuselage, and Fan Cowl
Fragment - Southwest Airlines 737-700 N772SW Engine Failure and
Decompression Philadelphia, 17 Apr 2018

Equipment Quality Analysis Report

TO: Air Safety Investigation (ASI) **EQA NUMBER:** AS12821
DATE: September 20, 2018
MODEL NUMBER: 737-700
AIRPLANE NUMBER: YA070

SUBJECT: ***Examination of Damaged Components Removed from Southwest Airlines (SWA) Aircraft YA070***

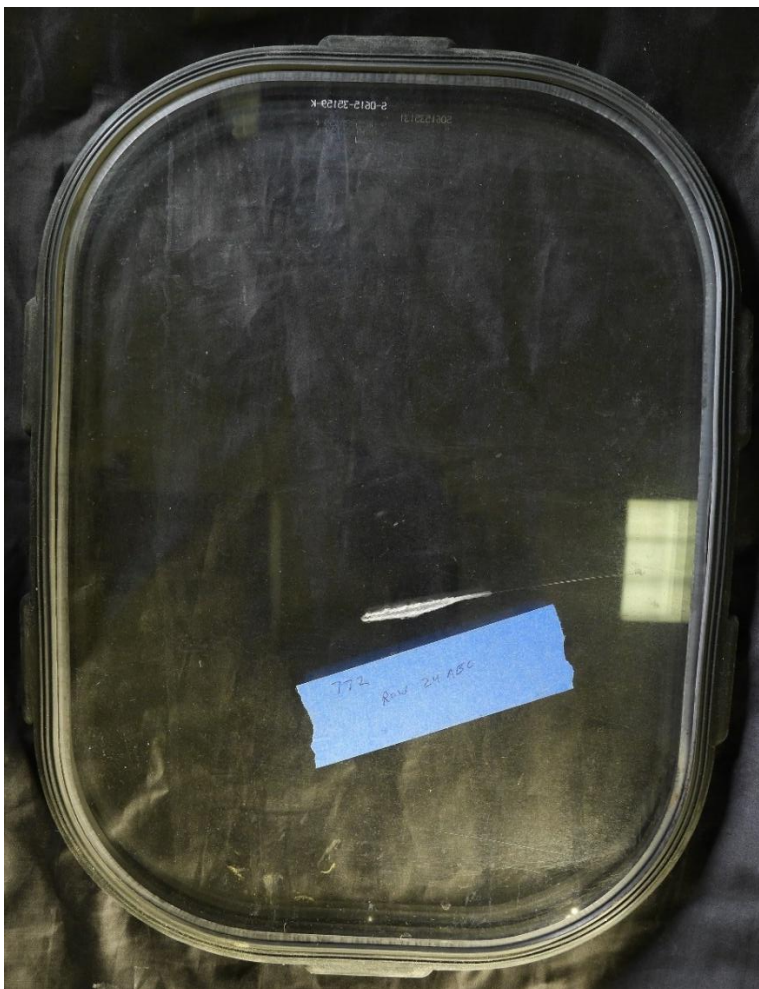
Figure 4: Overview of window assembly from row 24

Of the three passenger window assemblies received, only the row 24 window appeared to have sustained impact damage. The row 22 and 23 exterior window panes had witness marks, which consisted of an unidentified material that had been deposited on the surface of the pane. Per discussion and agreement between all parties present during the examination, the NTSB directed that the windows be delivered to BR&T for material identification of the witness marks on the row 22 and 23 windows, and to check for any residual foreign material in the damage of the row 24 window, with the understanding that destructive analysis may be required. BR&T found traces of aluminum in the damaged area of the row 24 window and on the witness mark of the row 22 window. The aluminum fragments most closely match 7000 series aluminum, but an exact match was not possible due to the small particle size. The material on the row 23 window had no trace evidence of aluminum, but carbon, oxygen, silicon, and sulfur were detected. See enclosure A for more details.

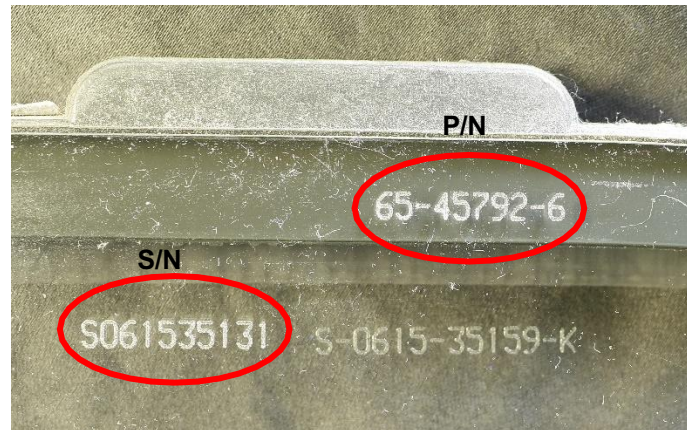
Figure 5: P/N and S/N of the middle pane of the row 24 window assembly

The P/N 65-45792-6 and S/N S061535131 of the row 24 window assembly middle pane are shown in Figure 5.

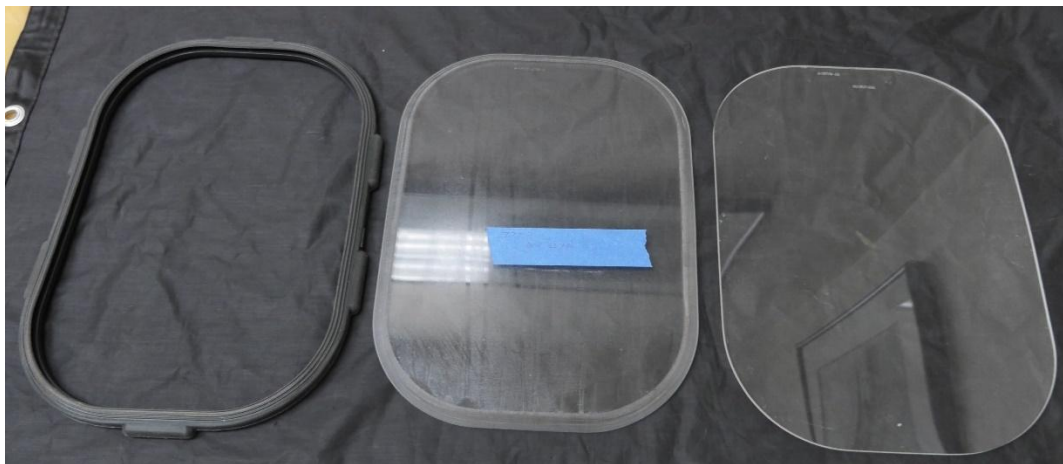
Under direction of the NTSB, the outer pane of the row 23 window was removed from the assembly and sent to BR&T for material identification of the witness mark; see Figure 11.

Figure 11: Row 23 window assembly disassembled

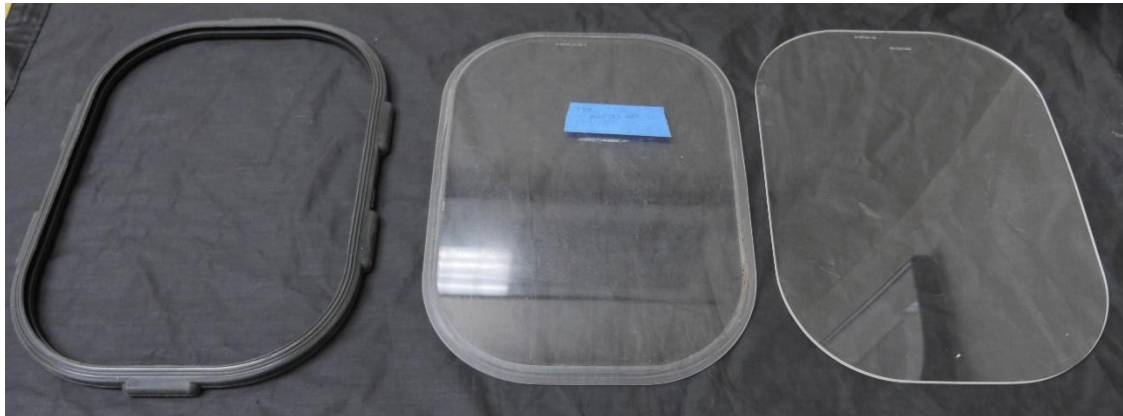
Under direction of the NTSB, the outer pane of the row 22 window was removed from the assembly and sent to BR&T for material identification of the witness mark; see Figure 15.

Figure 15: Row 22 window assembly disassembled

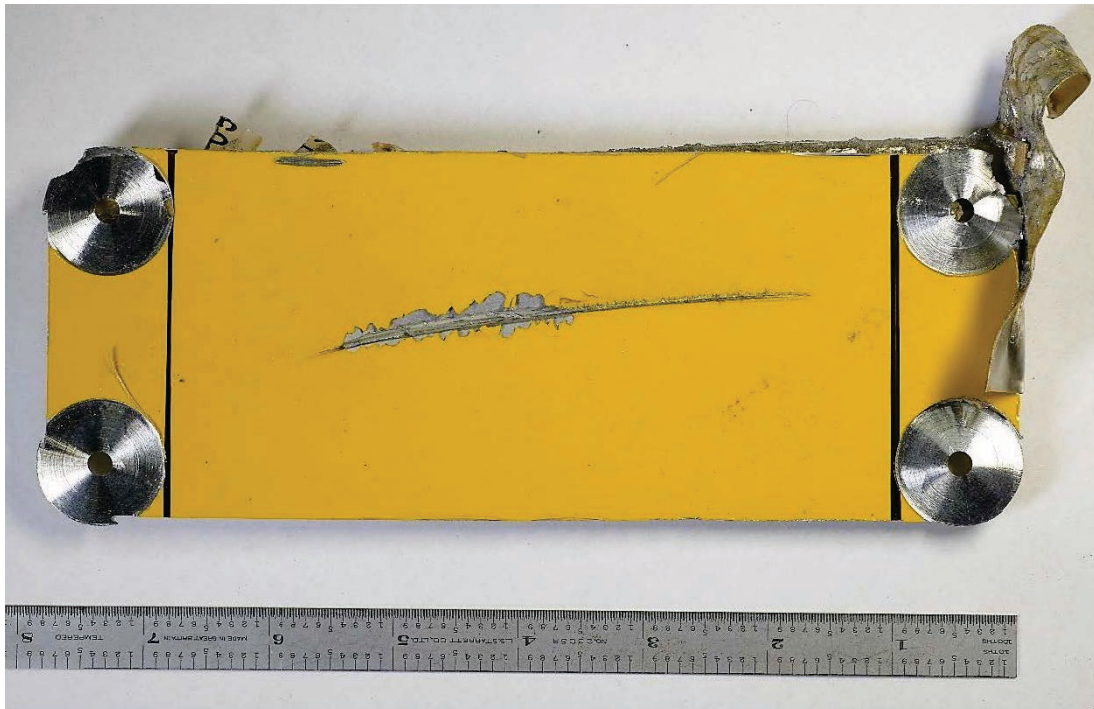
Figure 16: Overview of row 24 skin section

The skin section removed from approximately two feet above the row 24 window had an impact mark approximately 4.7 inches in length and 0.05 inch in width, which penetrated the skin. Per discussion and agreement between all parties present during the examination, the NTSB directed that the row 24 skin section be delivered to BR&T to check for any residual foreign material in the damaged area, with the understanding that destructive analysis may be required. BR&T did not find any residual foreign material in the damaged area of the skin. Only trace amounts of primer were present. See enclosure A for more details.

An overview of the fuselage skin section that was reportedly removed from approximately two feet above the left hand row 24 passenger window is shown in Figure 16.

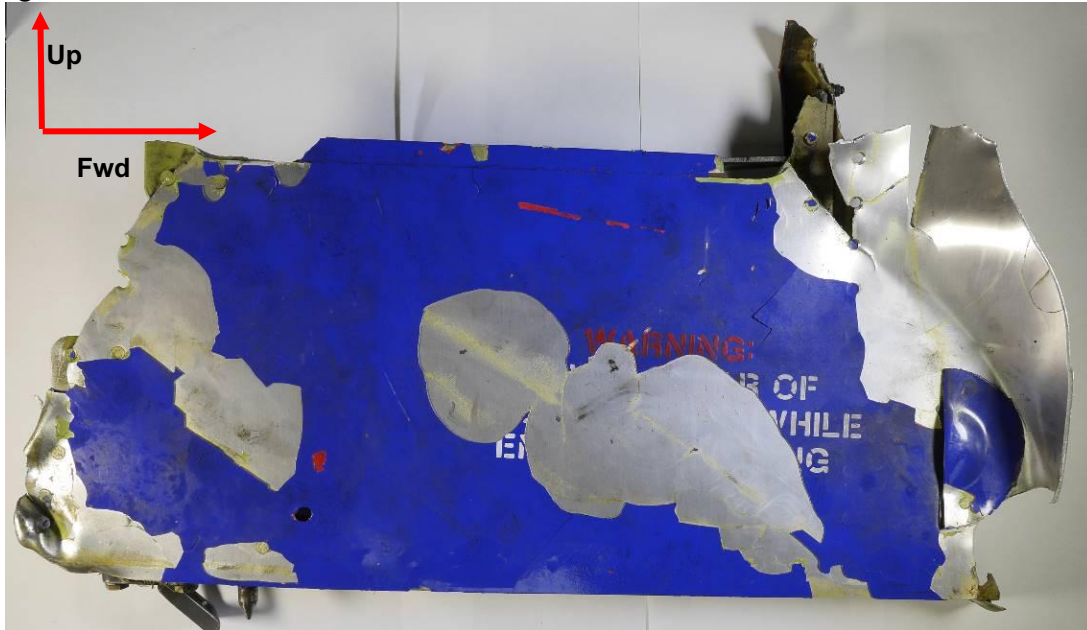
The left engine inboard fan cowl fragment, which had departed the aircraft and was recovered on the ground, showed evidence of impact damage. The fragment was determined to be from the lower aft corner of the inboard fan cowl.

The inboard fan cowl fragment was reportedly recovered from the ground beneath the approximate flight path of the subject aircraft. The fragment measured roughly 22 inches in length and 13 inches in width, and was identified as the lower aft corner of the inboard fan cowl. Overviews of the inboard fan cowl fragment are shown in Figure 22 and Figure 23.

Figure 22: Exterior overview of fan cowl fragment

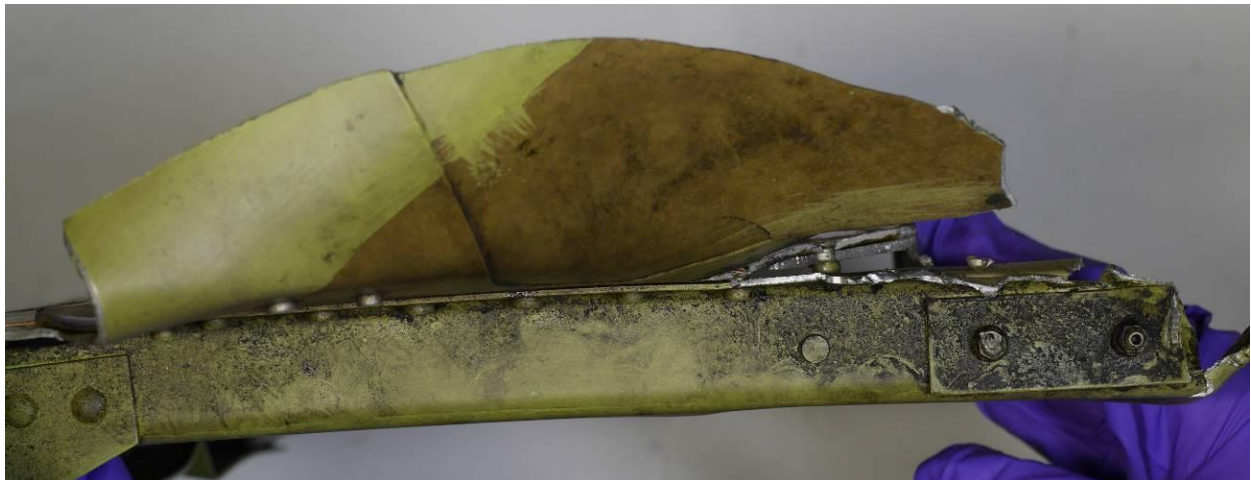
Approximately eight inches of the forward edge of the cowl fragment skin was folded outward; see Figure 26.

Figure 26: Forward edge of inboard fan cowl fragment

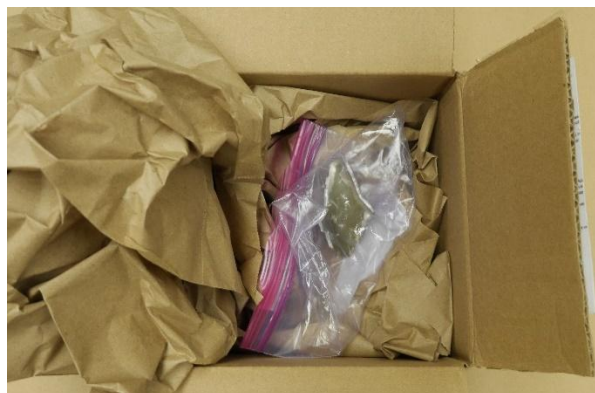
Figure 28: Inlet cowl fragment inside the packaging

The suspected engine inlet cowl fragment was found embedded in the skin of the left wing, aft of the number two slat. Under direction from the NTSB, the fragment was delivered to BR&T for material analysis. The BR&T analysis showed that fragment most closely matches 2000 series aluminum. See enclosure A for more details.

The suspected inlet cowl fragment was reportedly found imbedded in the fixed leading edge of the left wing during the initial damage assessment of the aircraft in Philadelphia. The fragment was removed at the scene and delivered to EQA by the NTSB on May 20, 2018. The fragment was approximately three inches in length and two inches in width; see Figure 29.

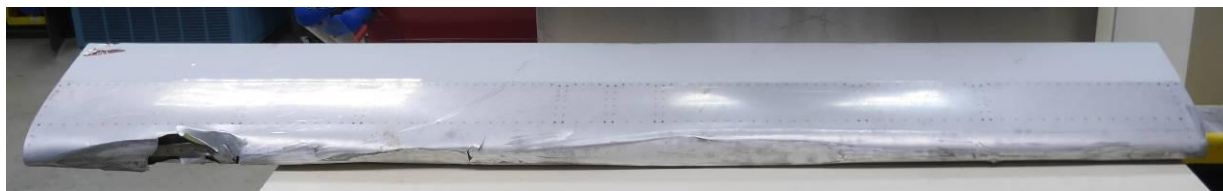
Figure 34: Overview of the upper surface of slat No. 2, with the outboard edge on the right of the image, and inboard edge on the left of the image

There was evidence of material scrapping along the leading edge as well as above it and below it. The leading edge was semi-flattened and dented in the following locations (measurements in inches from the outboard edge): 37-67 inches, 74-90 inches, 92-97

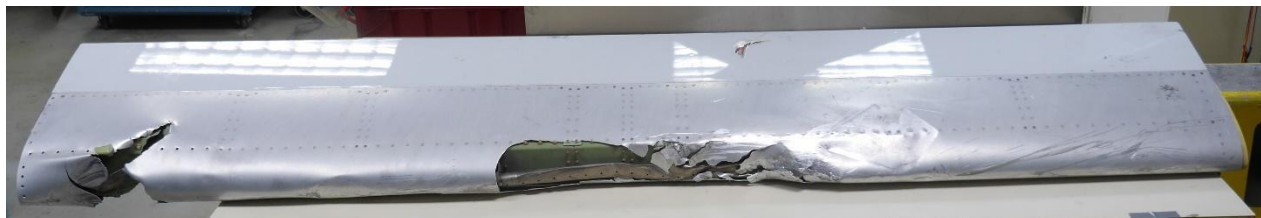
Figure 42: Overview of the upper surface of slat No. 3, with the outboard edge on the right of the image, and inboard edge on the left of the image

There was evidence of material scrapping along the leading edge as well as above and below it. An area of leading edge located approximately 101 to 112 inches from the outboard edge, was fractured with skin material missing. The anti-ice tubing was also crushed in the same area; see Figure 44. During the initial examination of the aircraft after the incident, it was reported that a metal fragment was removed from this area, and packaged in the same box as the passenger windows. The metal fragment edges appeared to correspond with the fractured skin in the slat, see Figure 45. Under direction of the NTSB, the metal fragment was sent to BR&T for material analysis.

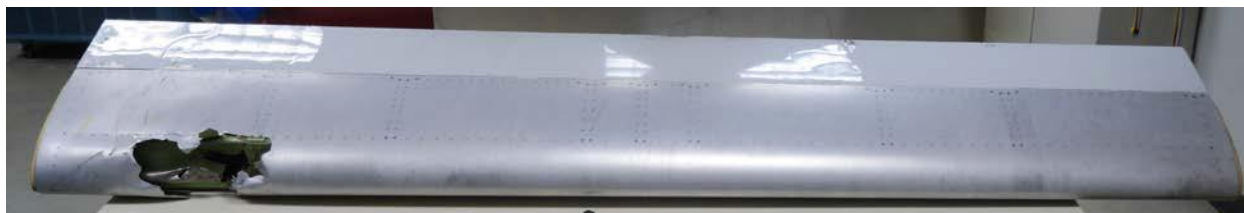
Figure 50: Overview of the upper surface of slat No. 4, with the outboard edge on the right of the image, and inboard edge on the left of the image

An area of leading edge located approximately between 94 and 109 inches from the outboard edge, was fractured with material missing creating a void, measuring about 14 inches in length and 9 inches in width. The anti-ice tubing in the area was crushed and severed. The forward edge of the nose beam was also punctured in the area behind the anti-ice tubing measuring about 5 inches in length and 5.5 inches in width.

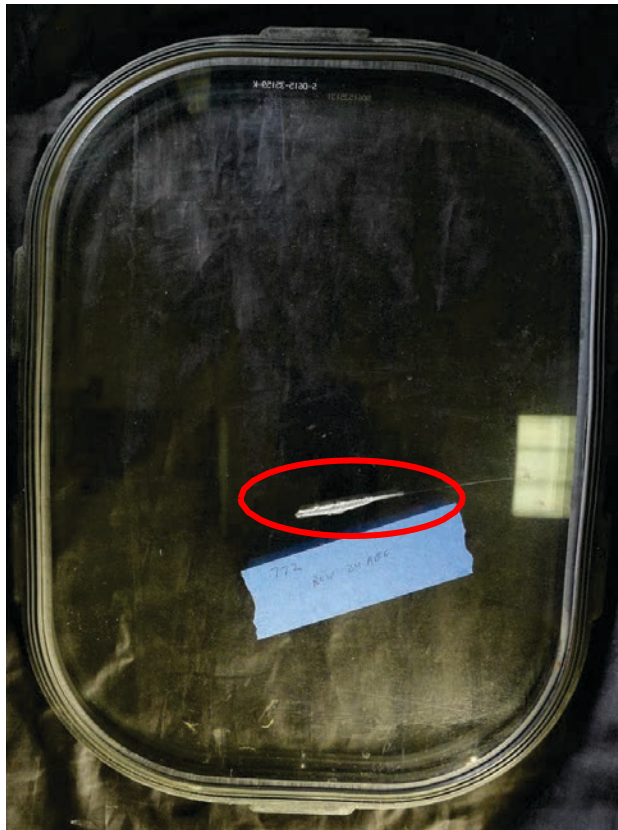
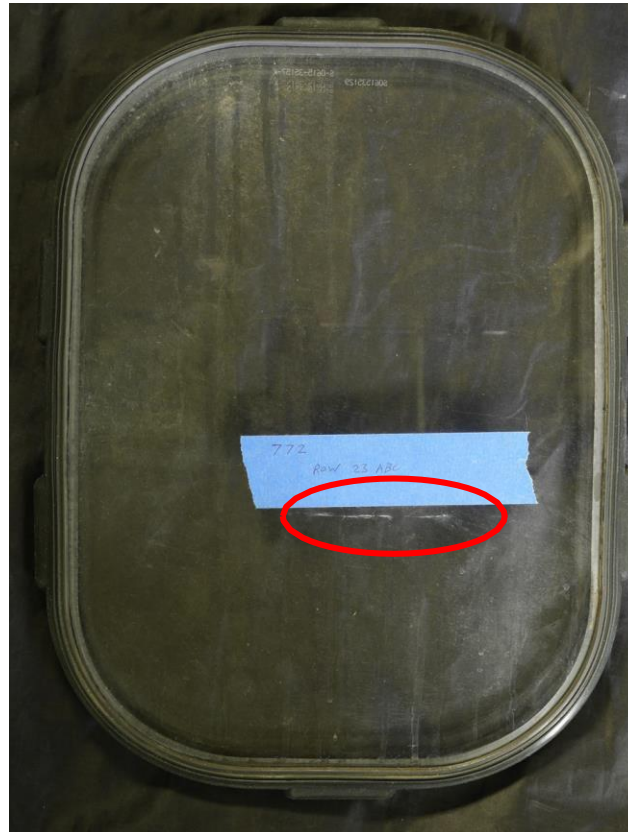
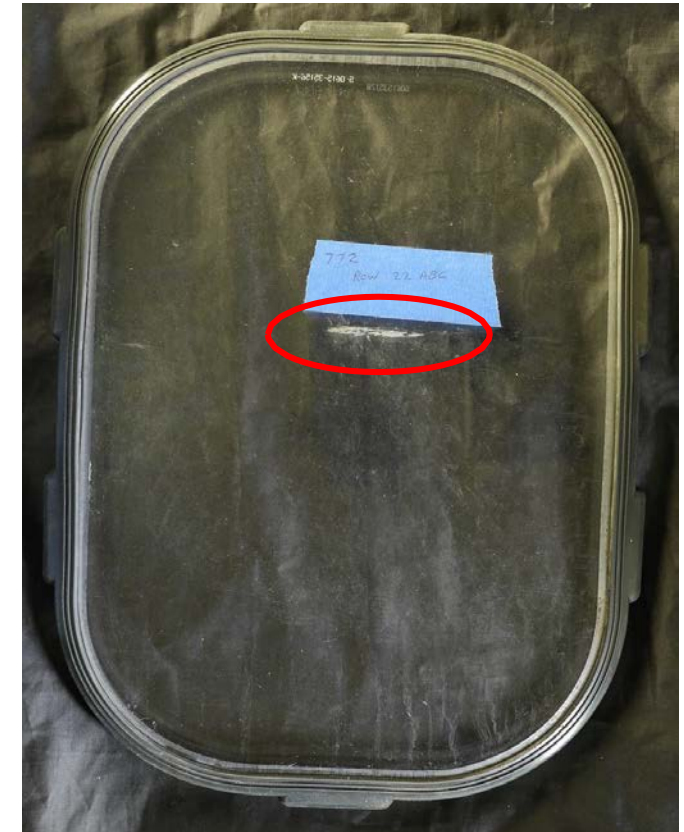
BR&T used scanning electron microscope (SEM) analysis to identify any residual contaminants remaining on the outer window panes. Trace amounts of aluminum fragments, as well as carbon, oxygen and small amounts of silicon were found in the damaged area of the row 24 window and on the witness mark of the row 22 window. The aluminum trace fragments most closely match 7000 series aluminum, but an exact match was not possible due to the small particle size. No trace amounts of aluminum were found on the row 23 window, but trace amounts of carbon oxygen, silicon, and sulfur were present. See enclosure A for more details.

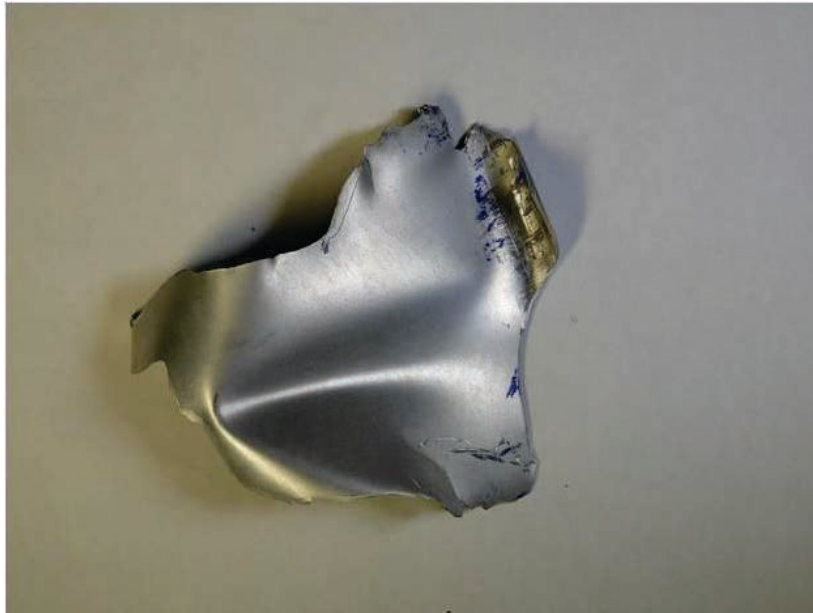
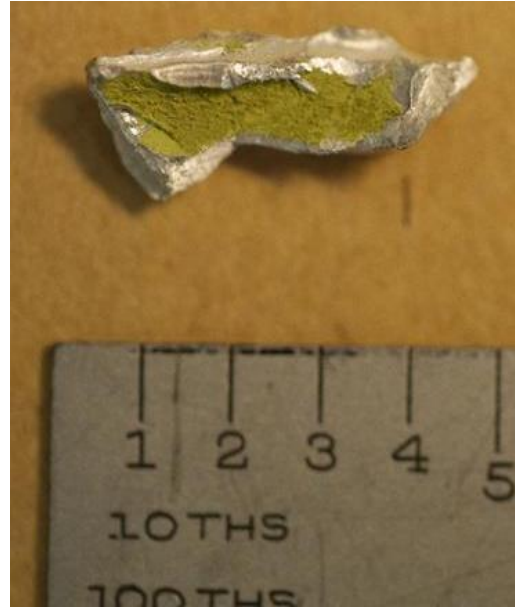
A metal fragment approximately a 0.5 inch in length and a 0.25 inch in width, was found inside the leading edge about 101 inches from the outboard side; see Figure 49. Under direction of the NTSB, the fragment was sent to BR&T for material analysis.

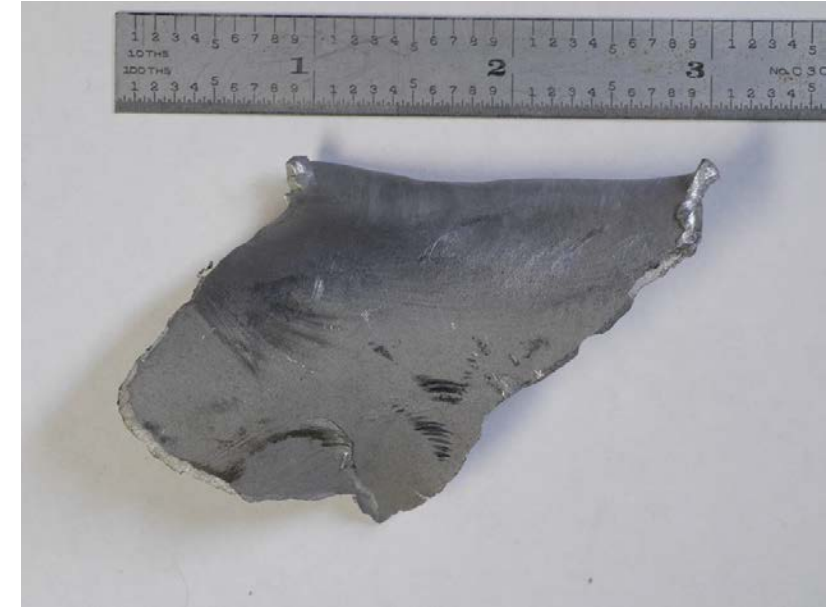
Fragment of inlet cowl assembly

BR&T used SEM and EDX analysis to identify the material of the suspected engine inlet cowl fragment that was found embedded in the skin of the left wing, aft of the number two slat. The analysis suggests that the fragment was a 2000 series aluminum alloy.

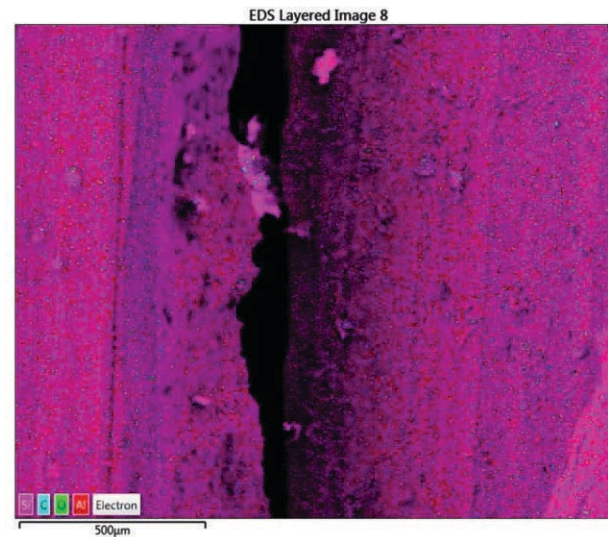
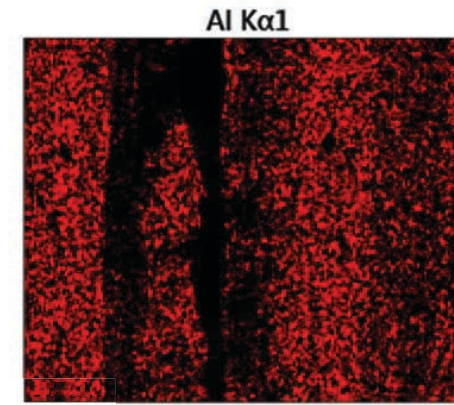
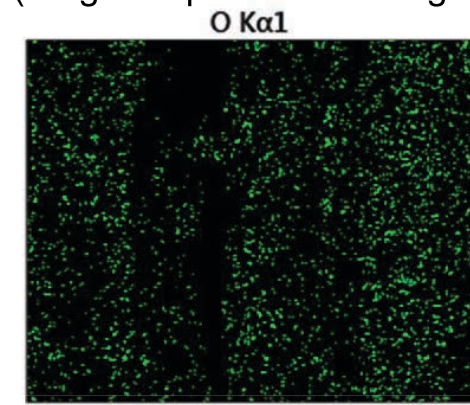
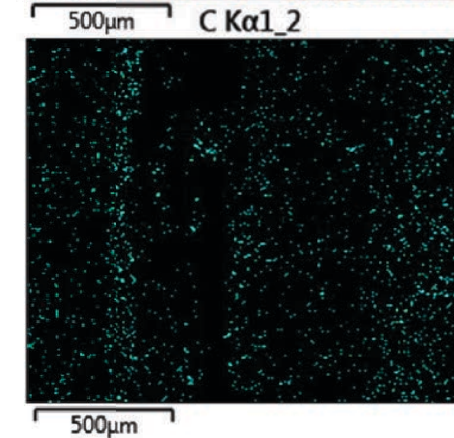
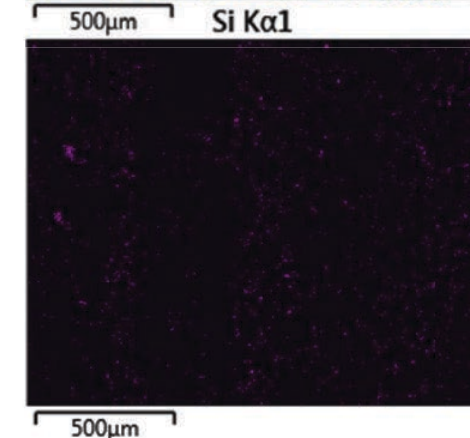
SEM Imaging – looking for metallic deposit on **Exterior Skin Rear #1** (Single Represented Image)

No Metallic fragments were found in this aluminum skin sample – only traces of Carbon, Oxygen, and Silicon

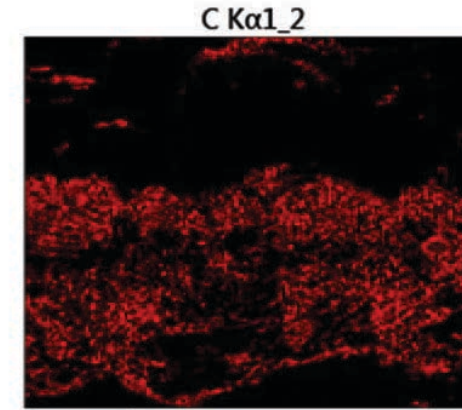
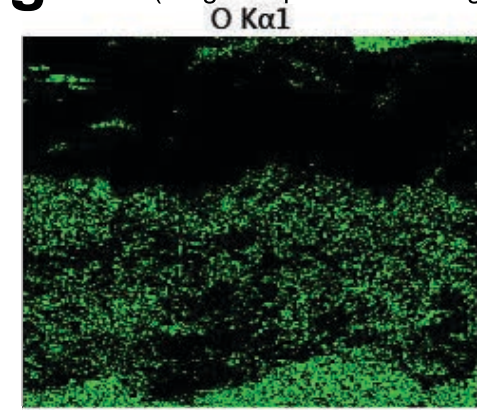
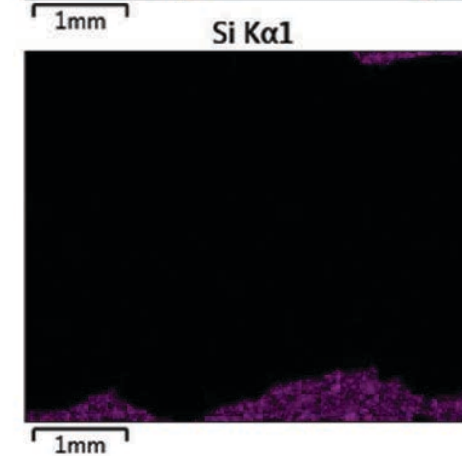
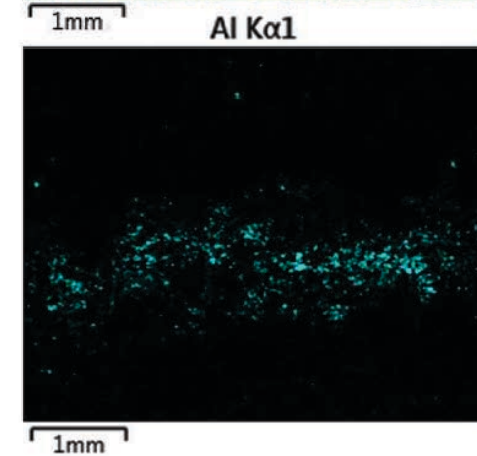
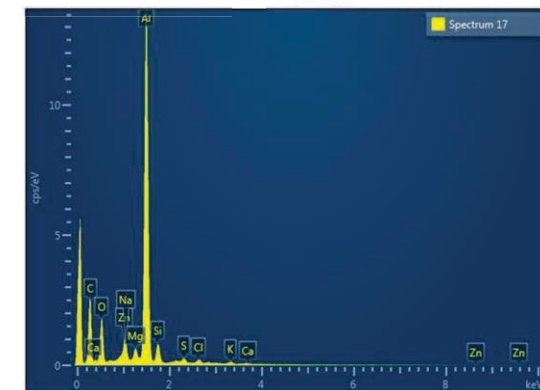
SEM Imaging – looking for metallic deposit in **Window Pane Covering #1** (Single Represented Image)

Trace amounts of Aluminum fragments were found in this sample. Also present is Carbon, Oxygen, and small amounts of Silicon

The Aluminum trace fragments most closely match the 7000 Series. An exact match is not possible due to the small particle size.

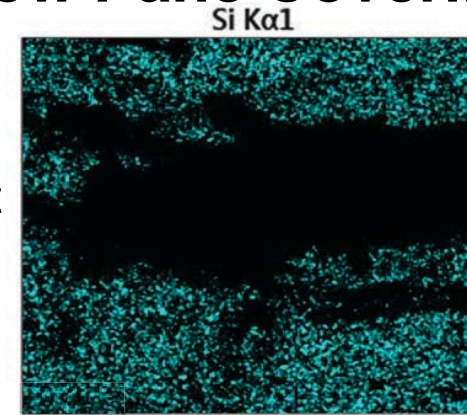
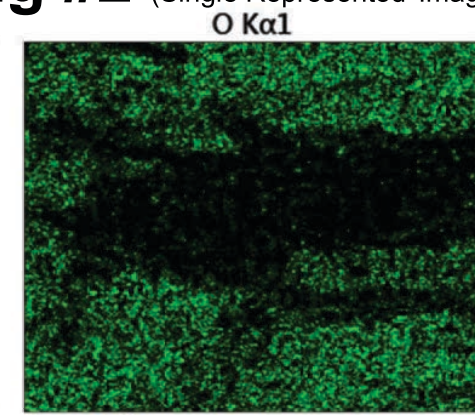
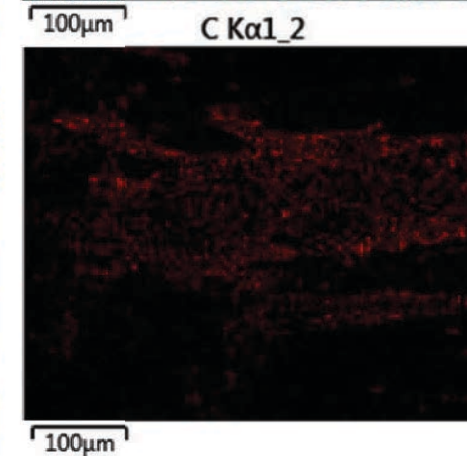
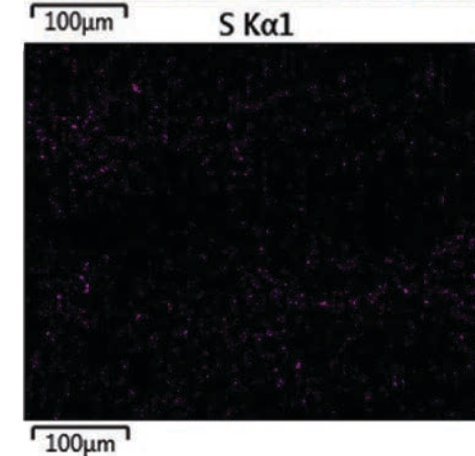
SEM Imaging – looking for metallic deposit in **Window Pane Covering #2** (Single Represented Image)

No trace amounts of Aluminum fragments were found in this sample. Present is Carbon, Oxygen, Silicon, and Sulfur

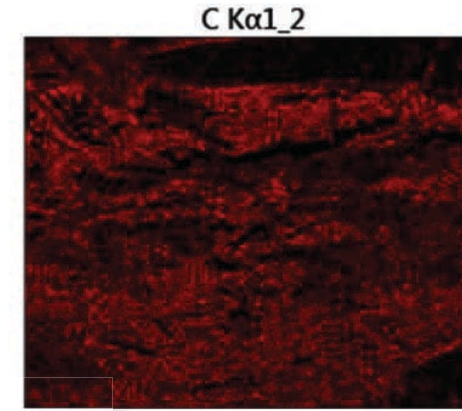
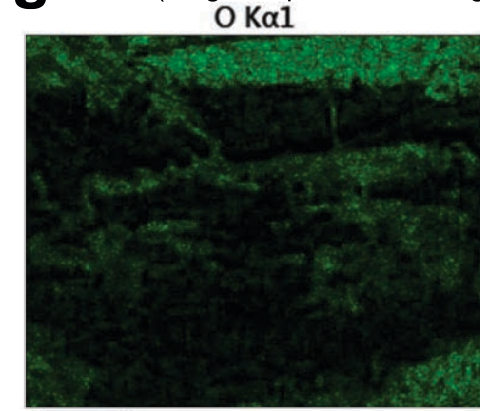
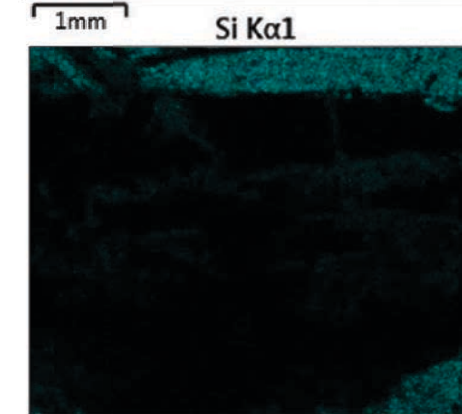
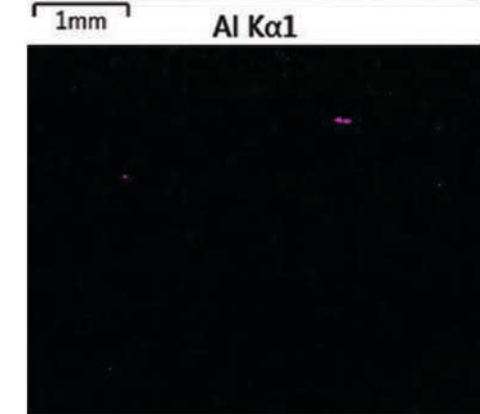
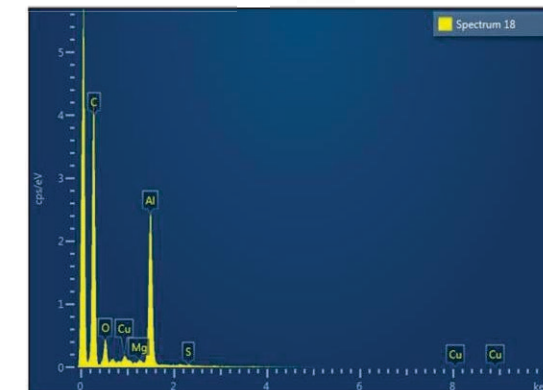
SEM Imaging – looking for metallic deposit in **Window Pane Covering #3** (Single Represented Image)

Trace amounts of Aluminum fragments were found in this sample. Also present is Carbon, Oxygen, and small amounts of Silicon

The Aluminum trace fragments most closely match the 7000 Series. An exact match is not possible due to the small particle size.

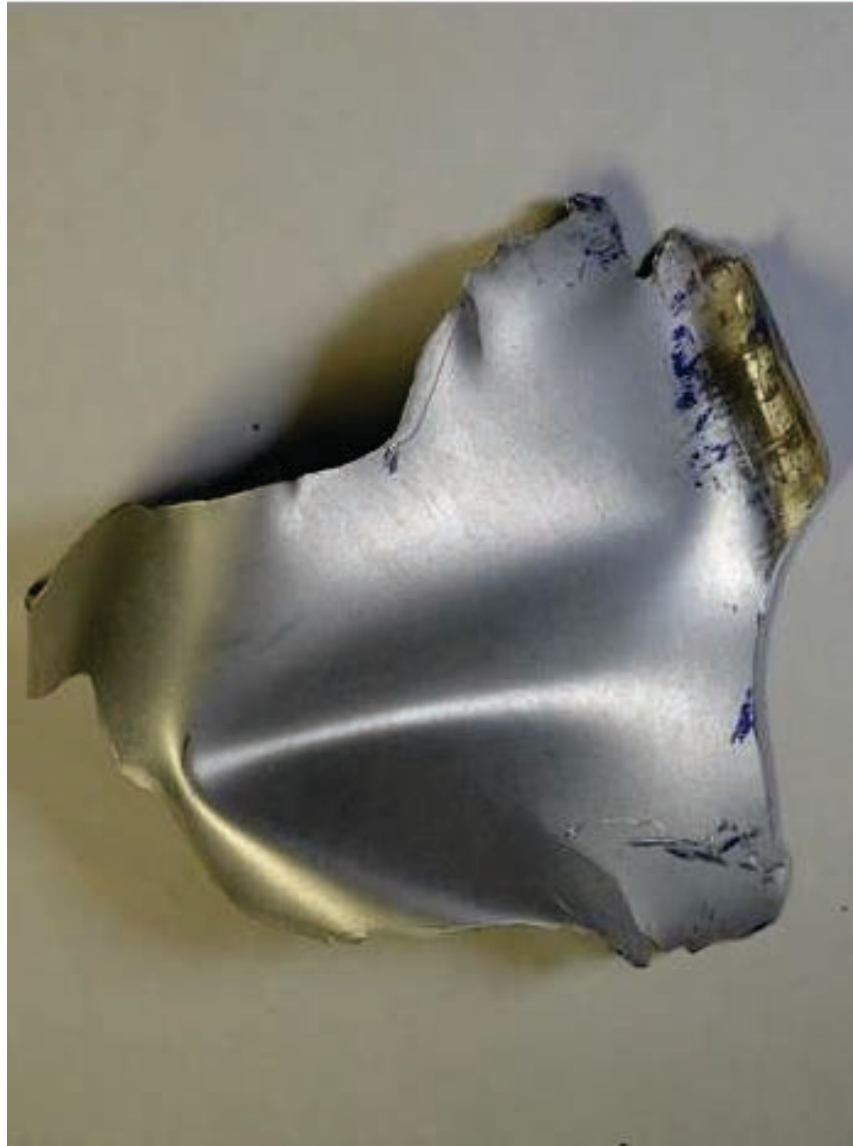
EDX Analysis – looking for metal composition **Slat #3 Fragment (Large)** (Single Represented Image)

Element	Wt%	Wt% Sigma
Mg	2.55	0.18
Al	88.80	0.60
Cu	2.11	0.46
Zn	6.54	0.43
Total:	100.00

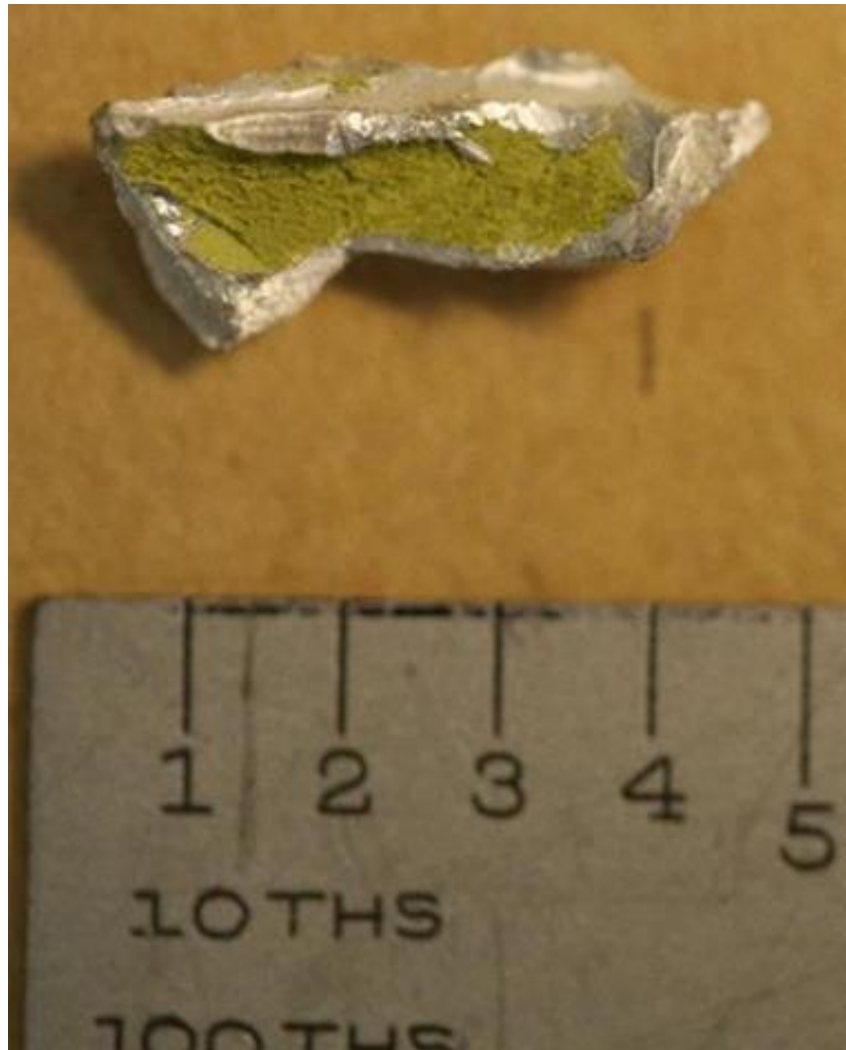
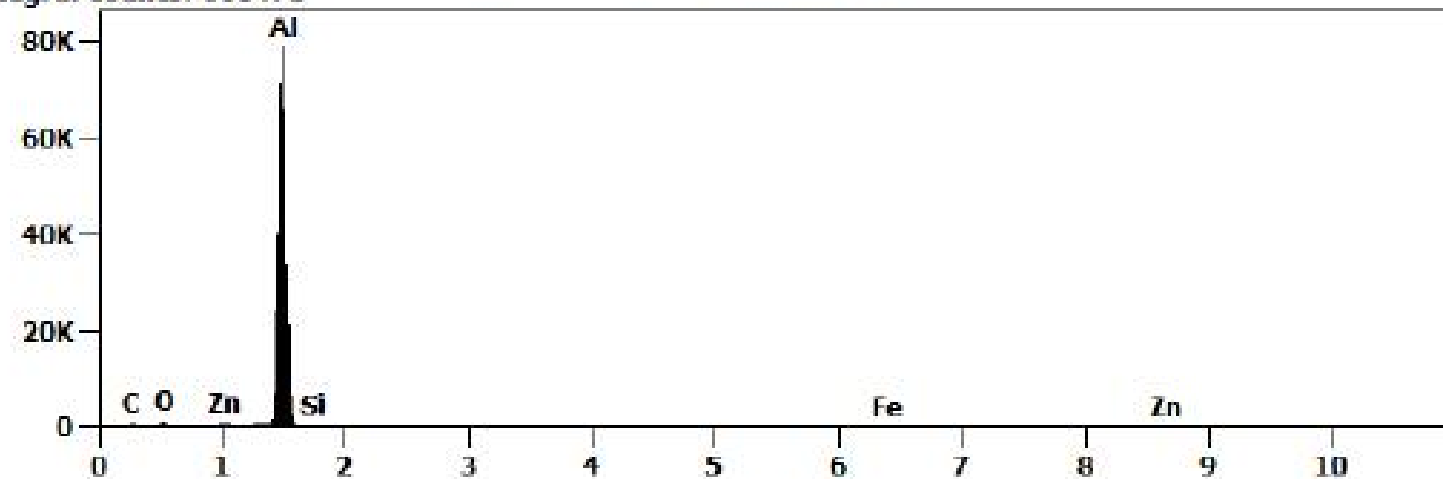
SEM Analysis - looking for metal composition **Slat #3 Fragment (Small)** (Single Represented Image)

Al	Si	Fe	Zn
Slat #3 Fragment (small)(2)_pt1	97.93	0.55	0.28	1.23

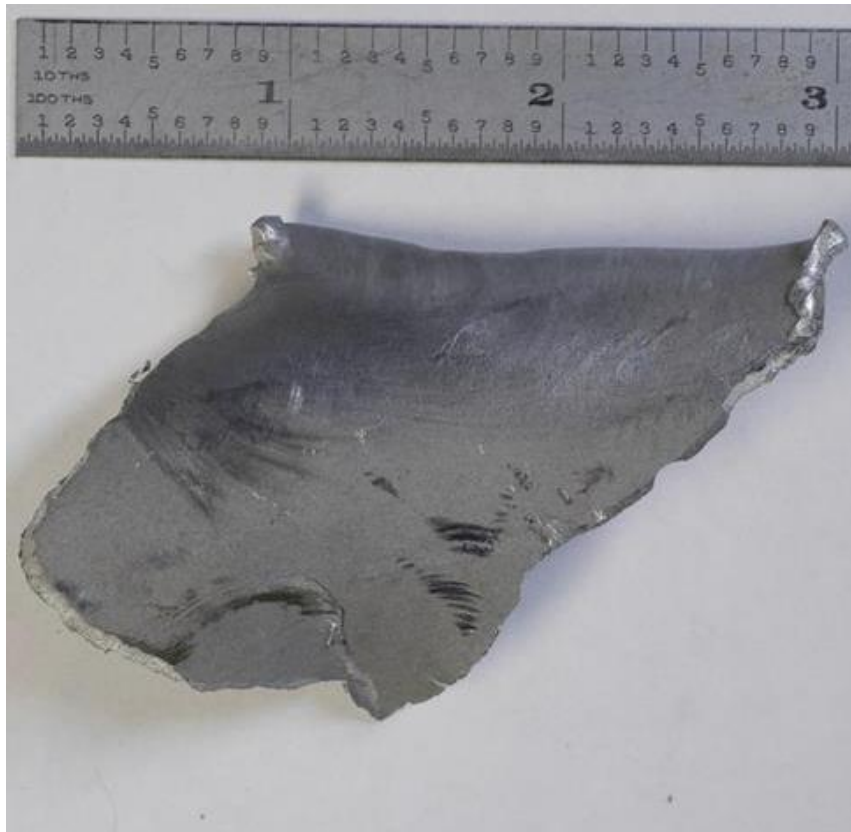
EDX Analysis - looking for metal composition **Fragment of inlet cowl assembly** (Single Represented Image)

Element	Wt%	Wt% Sigma
Al	93.72	0.26
Si	0.44	0.11
Cu	5.84	0.24
Total:	100.00
